# Analyzing Water Infrastructure and Community Resilience: A Technical Review on Kabalamapalaya Village

**Abstract:** This research provides an examination of the water scarcity and infrastructure challenges in Kabalamapalaya, a rural village in the Tumkur district, India, conducted through the Live-in-Labs® program. The village, which accounts for 3,659 residents, relies on five borewells, whereas the main purifier has been non-functional for months. As a result, the lack of water and untreated sources facilitate numerous health risks. The conducted tests demonstrate the increased number of total dissolved solids, hardness, and chloride, which indicates an urgent intervention of the issue. The research process implies the phenomena of community engagement, resource mapping, and implementation possibilities, revealing the need for the Smart Observation App that is intended to monitor the available water quality and availability. The obtained results suggest the appropriateness of interventions usage and the raised issue's availability to be developed in a closer discussion within the rural development research by incorporating technology, sustainable water management, and communit

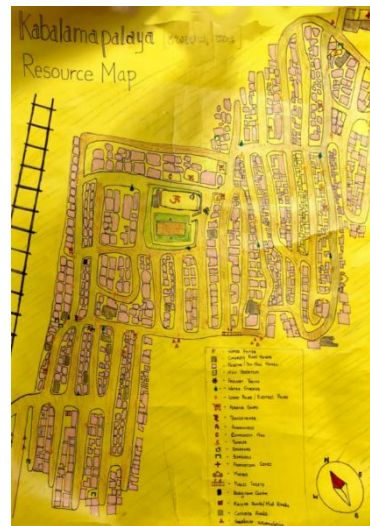
Fig. 1. Resource Map

The resource mapping in Kabalamapalaya has identified one of the key challenges and resources. Five borewells and few 3000-liter storage tanks are the main source of centralized water supply. However, all village's water is connected to one filter, which makes the quality and the quantity of water insufficient and unsafe. The same is true for electric supply since the transformer powers the whole village, which makes the system vulnerable. Few

Kirana shops and certain other specialized businesses provide for local commerce, but there is a potential for economic development. Azim Premji Foundation provides for health and childcare services, and there is an opportunity for early upbringing and development. However, I believe, the main challenge is a significant environmental hazard. Lowland areas and ditches are full of garbage and wastes, and they are not maintained since the government is not helping.

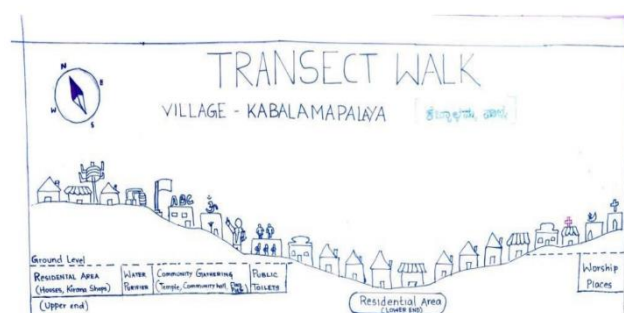
Fig. 2. Transect Walk

The Transact Walk in Kabalamapalaya has provided valuable insights into the state of infrastructure, water management, economic activities, and social context. It validated the position on the lack of infrastructure in many places, particularly the terrible conditions of the roads by the railway line and in low residential places. It also found that public transport cannot meet people's needs, as their operating hours do not match the working hours. The state of water management is similar, as the purifier is not enough to meet peak time demands. Sanitation in particular has worsened, as the toilets are all closed and others are unusable. The local economy remains of poor character, and the local business activity, most notably the wholesale Pani-puri shops, should be supported. The social context is better than many places, as the Azim Premji Foundation clinic seems to be doing well, and the Mosque is an important social and cultural hub.
