# AI-Driven Detection of Moisture Issues in Buildings Using Convolutional Neural Networks

**Abstract:-** This study presents the development and application of a Convolutional Neural Network (CNN) model for the detection and classification of moisture-related issues in buildings, specifically focusing on leakage, seepage, and dampness. The study highlights the challenges faced in data acquisition, including the similarities in visual characteristics of different moisture issues and the limitations posed by varying lighting conditions and image quality. A high-resolution mobile camera was employed to capture images, which were then processed using a CNN model. The results demonstrate the model's accuracy and reliability, with an overall classification accuracy of 94%.

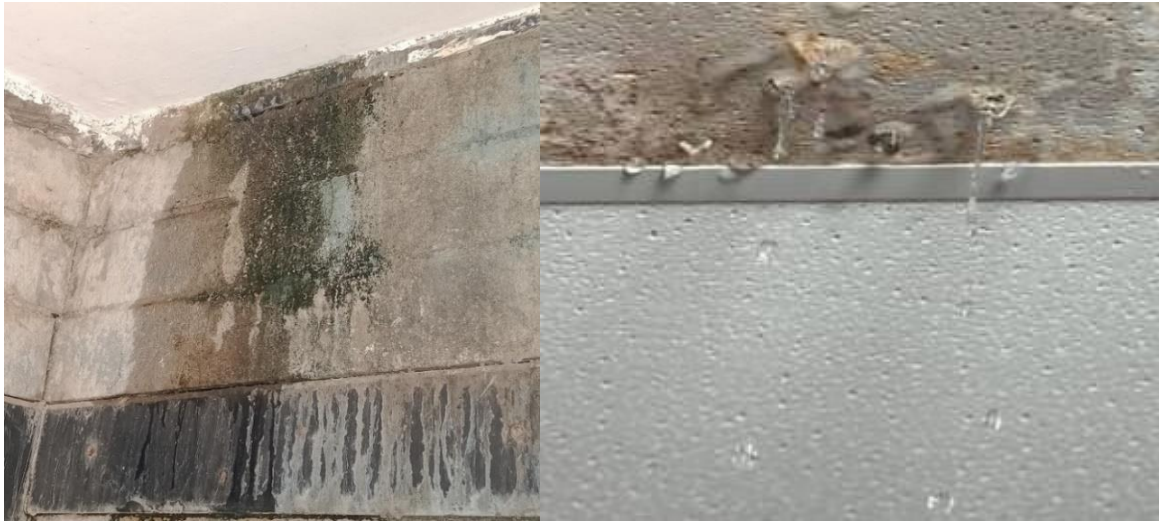
Figure 1. 1 - Leakage Images

Leakage occurs when water enters a building through external imperfections such as cracks in walls, roofs, or foundations. This can lead to structural damage, mold growth, and material deterioration. Causes include both structural issues, like roof leaks and cracks, and maintenance problems, such as plumbing leaks and poor sealing around windows and doors. To prevent moisture-related issues, regular roof maintenance, sealing cracks, and proper sealing of openings are essential. Mitigation involves repairing damaged roofing, addressing structural cracks, and fixing plumbing issues to protect the building from future water intrusion.

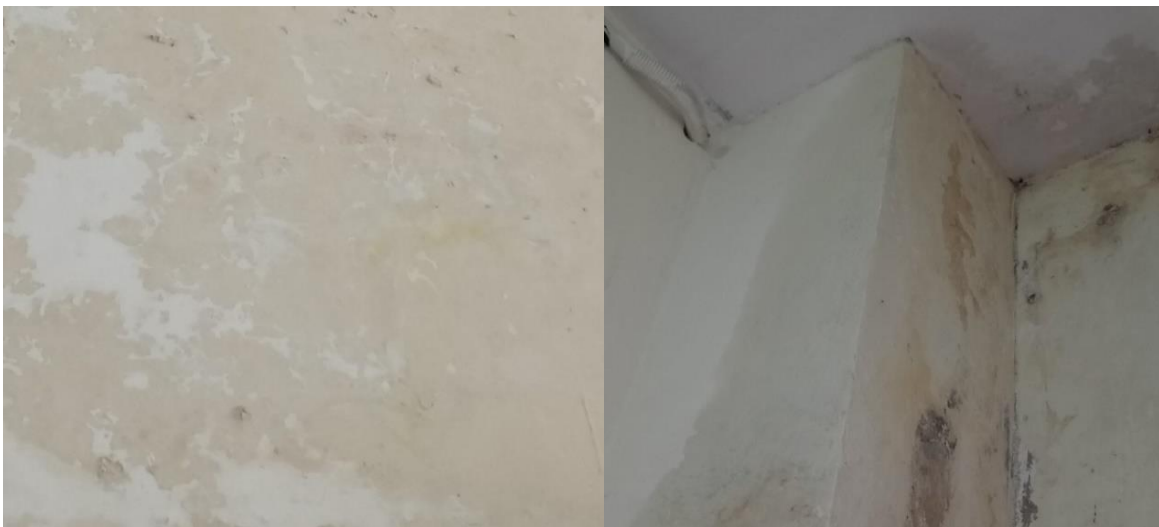
Figure 1. 2 - Seepage Images

Seepage is the slow infiltration of water through porous materials like soil, concrete, or masonry, often going unnoticed until it causes significant damage. It can weaken structural integrity, lead to mold growth, and result in dampness that damages walls and floors. Causes include elevated groundwater levels, inadequate waterproofing, structural defects, and poor drainage systems. Seepage can lead to issues like efflorescence, damp patches, and material deterioration, especially during freeze-thaw cycles. Prevention requires effective waterproofing, proper drainage, and high-quality construction materials. Mitigation involves sealing seepage paths, improving drainage, reinforcing waterproofing, and monitoring groundwater levels to avoid further damage.

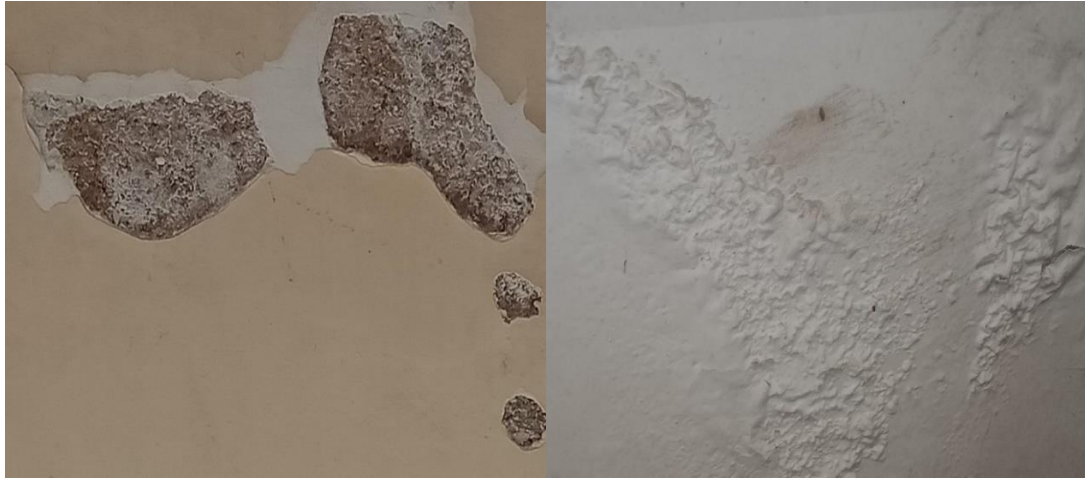
Figure 1. 3 - Dampness Images

Dampness occurs due to excessive moisture or high humidity within a building, often caused by leaks, poor ventilation, or inadequate insulation. It can manifest as visible moisture on walls, floors, or ceilings, often accompanied by musty odors and mold growth. Key factors include leaks, seepage, condensation, and moisture from indoor activities. Dampness can lead to health risks, such as respiratory issues, and cause structural damage, including decay, rot, and instability, especially in wooden structures. Prevention involves improving ventilation, using proper insulation, and controlling moisture sources. Mitigation includes enhancing airflow, upgrading insulation, installing moisture barriers, and repairing indoor moisture sources to protect both the building and its occupants.

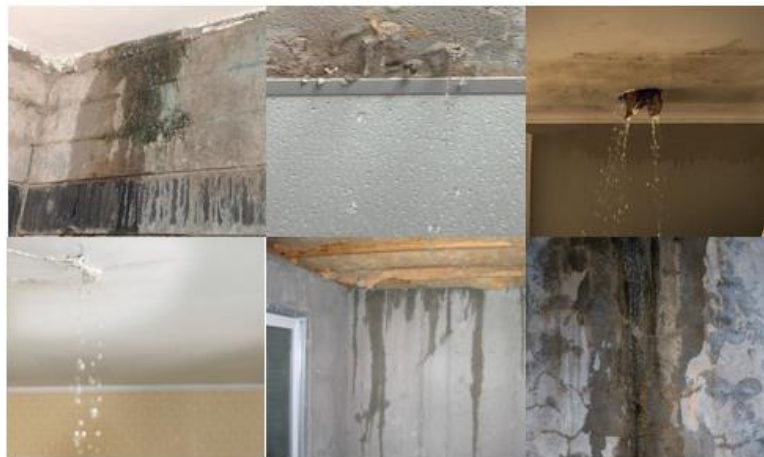
Figure 2. 2 - Leakage sample images

To train a model for detecting water-related issues in buildings, high-resolution images were collected from various surfaces, including walls, ceilings, and floors. The dataset includes 20 images of leakage, 126 of seepage, and 298 of dampness, all captured under consistent lighting and angles to ensure uniform quality. Images were carefully annotated with labels and bounding boxes to indicate the type and severity of damage. This thorough and organized data collection provides a strong foundation for training an accurate and effective model for water damage detection.

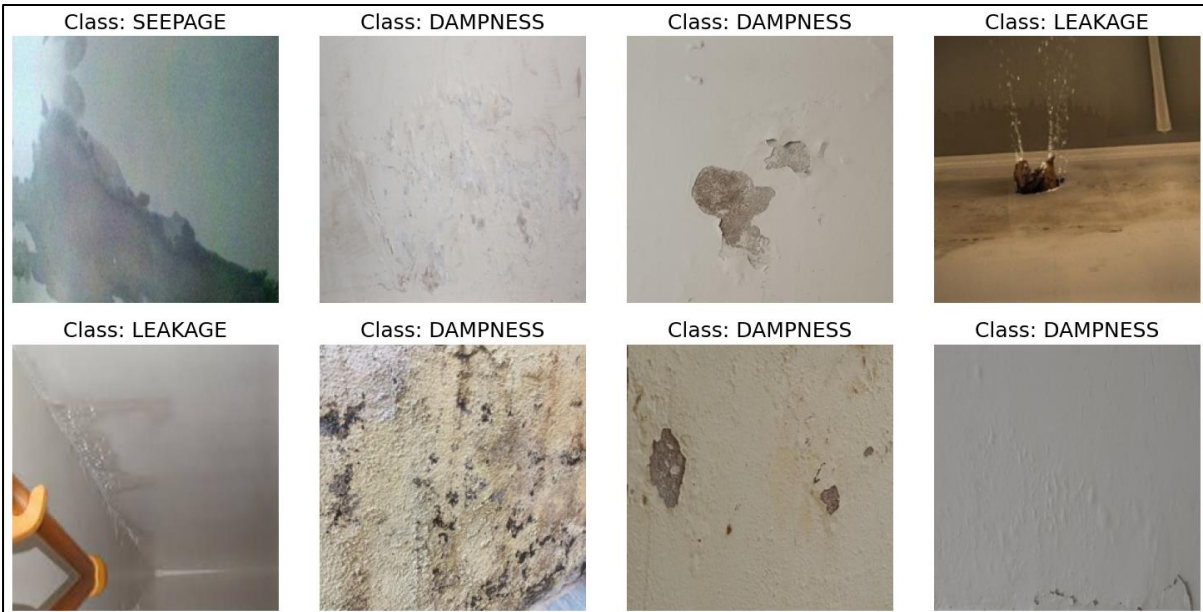
Figure 2.8 – Visual data of detected issues

Training involved adjusting the model's weights using a loss function and an optimizer, with careful control of the learning rate. The model's performance was monitored using a validation set to prevent overfitting, and early stopping was implemented to end training when improvement ceased. The final model's accuracy and precision were assessed, confirming its effectiveness in detecting water-related issues in building images.

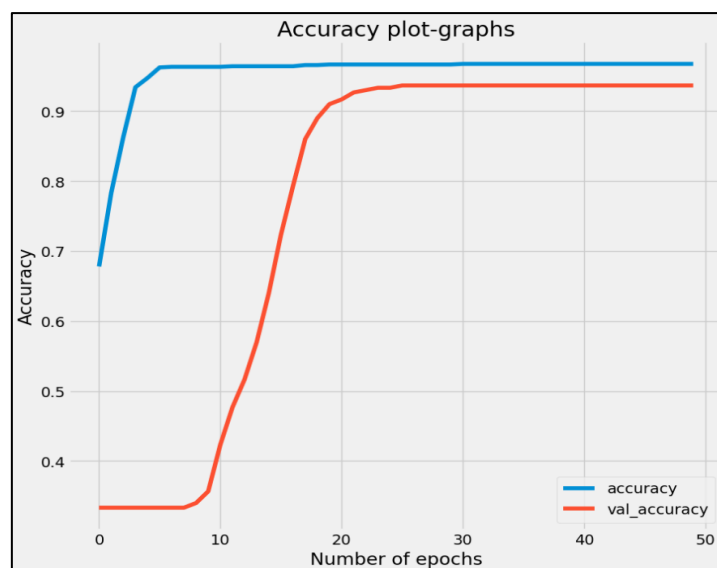
Figure 3. 3 - Accuracy Plot Graph of CNN

The accuracy plot shows rapid improvement in training accuracy, reaching 97.09% after 50 epochs, while validation accuracy plateaus at 93.67%, indicating potential overfitting. To mitigate this, techniques like early stopping and learning rate adjustments are suggested to enhance generalization and improve validation accuracy.

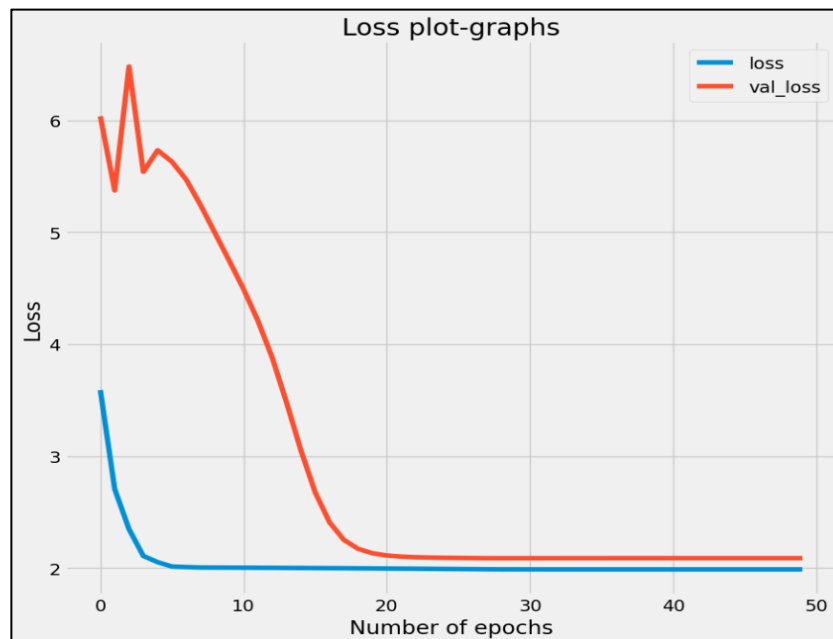
Figure 3. 4 - Loss Plot Graph of CNN

The loss plot illustrates the model's learning process, with both training and validation losses decreasing over time. The alignment of training and validation losses suggests that the model generalizes well without significant overfitting. Further improvements could be achieved by fine-tuning hyperparameters, though the model already shows reliable performance on both training and validation datasets.
